Accessibility Audit

Farndon Primary School

Farndon

Date 19/11/2018

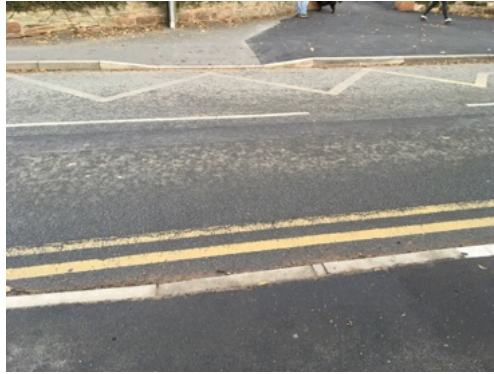
Photo 2

<p>Photo 2</p> </div> </div>		
<p>1.3 - Wide enough? If a route or pathway is narrow, is there a suitable passing place for wheelchair users? Is plantation trimmed back and are low branches avoided?</p>	C	<p>The pathway to the right side of the site in which parents will bring their children appears to have a steeper gradient than previously. It is recommended that a free standing hand rail be installed to the right side of the pathway.</p>

Refer to 1.3, The pathway to the right side of the site in which parents will bring their children appears to have a steeper gradient than previously. It is recommended that a free standing hand rail be installed to the right side of the pathway.

PRIORITY C				
1.3	The pathway to the right side of the site in which parents will bring their children appears to have a steeper gradient than previously.	<p>It is recommended that a free standing hand rail be installed to the right side of the pathway.</p> <p>This should be well contrasted and not cold to touch. The handrails need to be one with a suitable profile (circular: 40 – 45mm, oval 50mm, in diameter)</p>	M

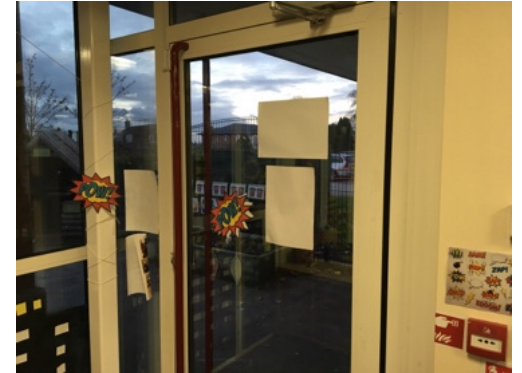
Photo 21

<p>Photo 21</p>		
7.2 - Free from obstruction to wheel chair users and from hazards to people with impaired sight? Are there any internal columns that have a lack of colour contrast?	Yes / N/A	There were no internal hazards identified as part of the survey. No issues to report.

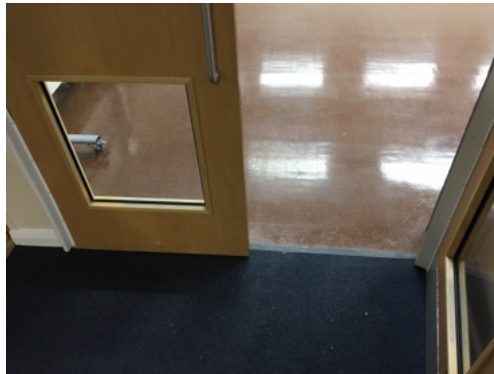
Photo 23

<p>Photo 23</p>		
8.2 - Glass door: clearly visible when closed? Are manifestations suitably colour contrasted against the background?	B	The fully glazed doors within the new build have the appropriate manifestations provided at two heights. The fully glazed doors out of the pre-school still require manifestations to ensure that a potential collision hazard is minimised.

8.2	<p>The fully glazed doors within the new build have the appropriate manifestations provided at two heights. The fully glazed doors out of the pre-school still require manifestations to ensure that a potential collision hazard is minimised.</p>	<p>Well contrasted manifestations should be provided at two heights to the doors.</p> <p>Glazed doors need to have permanent strips on the glass within a zone of 1.4mm to 1.600mm from the floor. These strips need to be contrast in colour (not treated glass) and luminance with the background seen through the glass in all light conditions.</p>	M

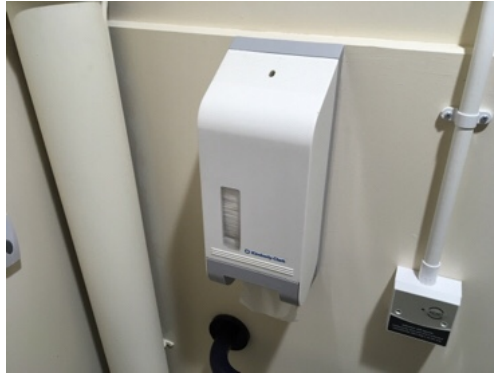
Photo 39

<p>Photo 39</p>		
13.2 - Travel distance to a suitable WC no greater than that for able-bodied people?	A	It is disappointing that an accessible WC was not constructed within the new build. At current this would result in disabled people in having to exit the new build and go to the main school in order to reach a suitable facility. It is strongly recommended that the toilet that staff are currently using within the new build be adapted into a BS8300 unisex accessible WC facility.

13.2	It is disappointing that an accessible WC was not constructed within the new build. At current this would result in disabled people in having to exit the new build and go to the main school in order to reach a suitable facility.	<p>It is strongly recommended that the toilet that staff are currently using within the new build be adapted into a BS8300 unisex accessible WC facility.</p> <p>BS8300 should be referred to for the suggested layout and guidance.</p> <p>An alarm should be installed within the facility and the fittings should be well contrasted.</p>	M

Refer to 13.2, It is disappointing that an accessible WC was not constructed within the new build. At current this would result in disabled people in having to exit the new build and go to the main school in order to reach a suitable facility. It is strongly recommended that the toilet that staff are currently using within the new build be adapted into a BS8300 unisex accessible WC facility.

recommended that the toilet that staff are currently using within the new build be adapted into a BS8300 unisex accessible WC facility.

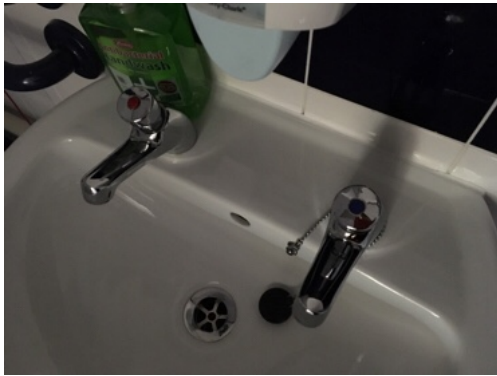
Photo 42

<div data-bbox="114 946 392 1225" data-label="Image"> </div> <div data-bbox="210 1241 293 1262" data-label="Caption"> <p>Photo 42</p> </div> <div data-bbox="461 946 736 1225" data-label="Image"> </div> <div data-bbox="557 1241 640 1262" data-label="Caption"> <p>Photo 43</p> </div> <div data-bbox="808 946 1084 1225" data-label="Image"> </div> <div data-bbox="904 1241 987 1262" data-label="Caption"> <p>Photo 44</p> </div>		
<p>13.6 - Tap appropriate for use by a person with limited dexterity, grip of strength?</p>	<p>A</p>	<p>The far left side accessible WC has push taps instead of the recommended single lever mixer tap.</p>

13.6	The far left side accessible WC has push taps instead of the recommended single lever mixer tap.	A new hand wash basin should be installed within the accessible WC that has a single lever mixer tap.	M
