Accessibility Audit

Farndon Primary School

Farndon

Date 19/11/2018

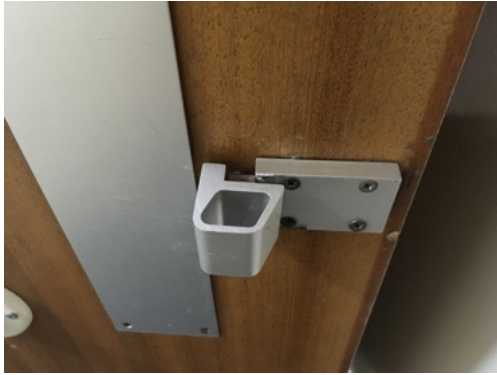
Photo 37

Refer to 13.2, It is disappointing that an accessible WC was not constructed within the new build. At current this would result in disabled people in having to exit the new build and go to the main school in order to reach a suitable facility. It is strongly recommended that the toilet that staff are currently using within the new build be adapted into a BS8300 unisex accessible WC facility.

recommended that the toilet that staff are currently using within the new build be adapted into a BS8300 unisex accessible WC facility.

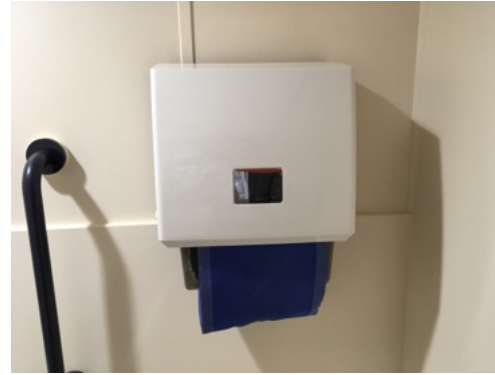
Photo 39

<p>Photo 39</p>		
13.2 - Travel distance to a suitable WC no greater than that for able-bodied people?	A	It is disappointing that an accessible WC was not constructed within the new build. At current this would result in disabled people in having to exit the new build and go to the main school in order to reach a suitable facility. It is strongly recommended that the toilet that staff are currently using within the new build be adapted into a BS8300 unisex accessible WC facility.

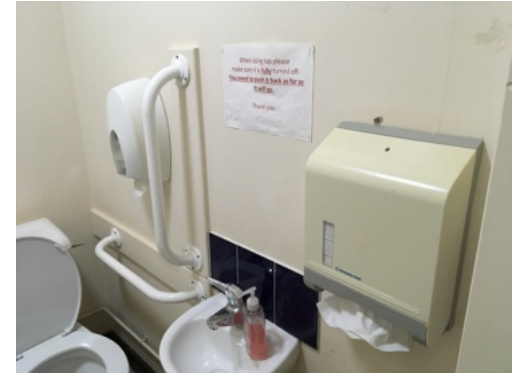
Photo 40

<p>Photo 40</p>		
13.3 - Sufficient space available outside toilet compartment for manoeuvre? Is the entrance wide enough and does it open outwards?	Yes / N/A	All of the accessible WCs have an outward opening door. No issues to report.
